Manhole Inspection Summary

Manhole # S55S__003MH

Insp Date: **7/9/08 10:09 AM**

Location Address: **1600s. clinton st**

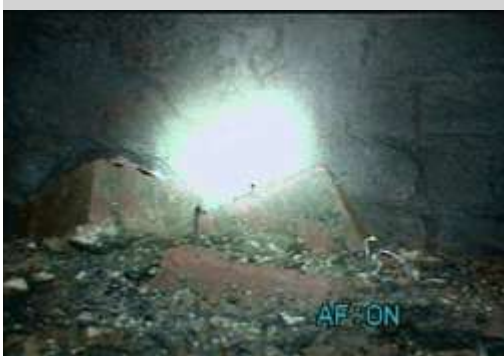
Defect 3

Condition: ☐ Sound ☐ Cracked ☐ Root Intrusion ☐ Deteriorated ☐ Leaks ☒ **Debris**

debris

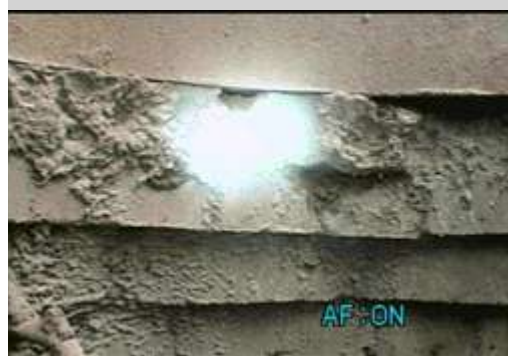
Defect 2

Infiltration: ☐ None ☒ **Joint** ☐ Cracks ☐ Mortar ☐ Roots ☐ Wall

Chimney Infiltration

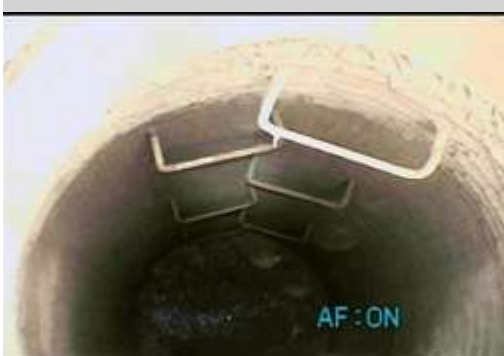
Defect 1

Steps Count: **6** Missing: **0** ☒ **Corroded**

steps

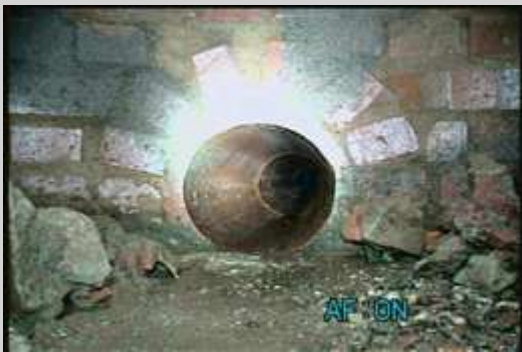
12 O'Clock Outflow

Silt Depth: 0 (in.) Deposits Extent: **Heavy**

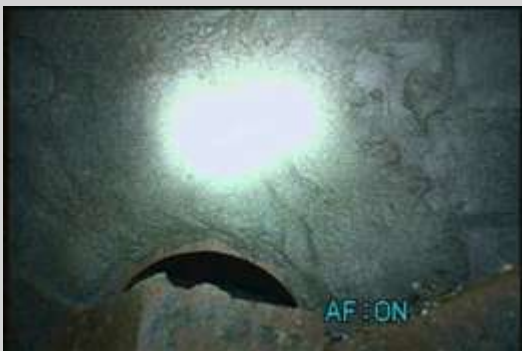
3 O'Clock Inflow

Deposits: ☐ None ☐ Mud ☐ Sludge ☒ **Debris** ☐ Grease

Silt Depth: 6 (in.) Deposits Extent: **Heavy**
